DEPARTMENT OF TRANSPORTATION

Quality Assurance and Source Inspection

Contract #: 04-0120F4Cty: SF/ALA Rte: 80 PM: 13.2/13.9File #: 99.28**WELDING INSPECTION REPORT****Resident Engineer:** Siegenthaler, Peter**Address:** 333 Burma Road**City:** Oakland, CA 94607**Report No:** WIR-022796**Date Inspected:** 19-Apr-2011**Project Name:** SAS Superstructure**OSM Arrival Time:** 700**Prime Contractor:** American Bridge/Fluor Enterprises, a JV**OSM Departure Time:** 1900**Contractor:** Zhenhua Port Machinery Company, Ltd (ZPMC) Chanxing Island**Location:** Shanghai, China**CWI Name:** Mr. She Lei**CWI Present:** Yes No**Inspected CWI report:** Yes No N/A**Rod Oven in Use:** Yes No N/A**Electrode to specification:** Yes No N/A**Weld Procedures Followed:** Yes No N/A**Qualified Welders:** Yes No N/A**Verified Joint Fit-up:** Yes No N/A**Approved Drawings:** Yes No N/A**Approved WPS:** Yes No N/A**Delayed / Cancelled:** Yes No N/A**Bridge No:** 34-0006**Component:** OBG Segment**Summary of Items Observed:**

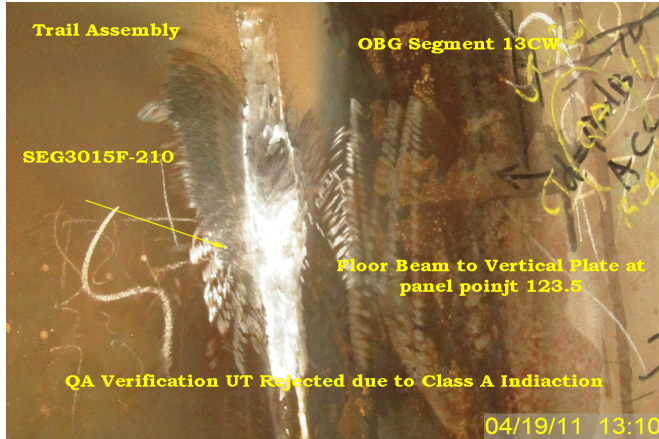
Description of Incident: During the Quality Assurance Ultrasonic Testing (UT) verification of weld located on OBG Segment 13CW, this Quality Assurance Inspector (QA) discovered the following issue:

- One (1) Class “A” indication measuring approximately 25mm in length.
- The Indication rating is +8dB and length approximately 25mm.
- The nominal thickness of the plate is 14mm and depth of the indication approximately 5mm.
- The indication is located on the weld joint identified as SEG3015F-210.
- The “Y” location for this indication is approximately 160mm from top of this weld.
- The weld is a Complete Joint Penetration (CJP) “T” weld joint joining Floor Beam to Vertical Plate at panel point

123.5.

- The indication is clearly marked by QA on/near the weld.
- This weld is designated as non Seismic Performance Critical Member (non SPCM).
- OBG Segment 13CW is located in Trail Assembly North Side.
- The Notice of Witness Inspection Number (NWIT) is 008865.
- The indication is located within the area that has been previously tested and accepted by ZPMC Quality Control (QC) personnel.
- As per the contract documents, ZPMC's QC personnel are required to perform 100% UT inspection of this weld. See the attached picture.

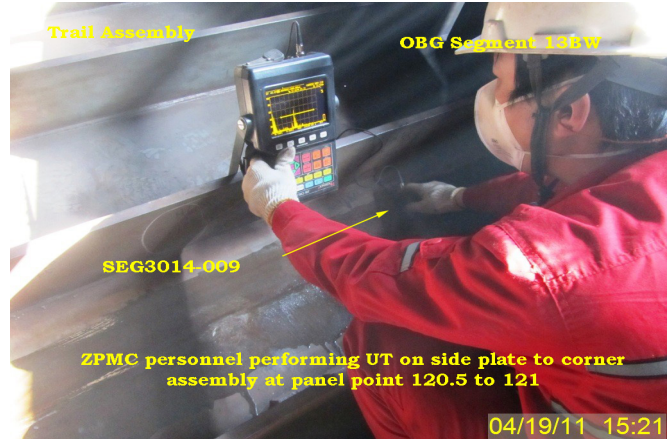
This QA inspector observed ZPMC personnel performed Ultrasonic Testing (UT) on Side Plate to Corner Assembly at panel point 120.5 to 121 of OBG Segment 13BW. See the attached picture.
